## Symwave SW3080 v.CD Silicon Errata

Last Updated: 2/20/2008 5:00:00 PM

Symwave SW3080 IEEE-1394b S800 THREE PORT CABLE TRANSCEIVER/ARBITER

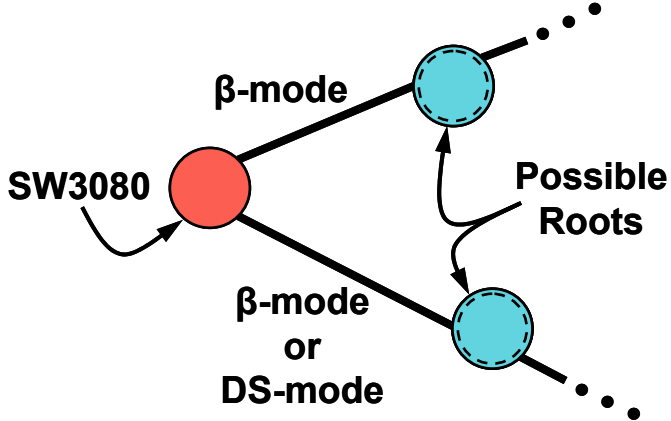
SILICON ERRATA ID	PROBLEM DESCRIPTION	RESOLUTION / WORK-AROUNDS
<p>1. Gap-before-Ack Issue</p>	<p><u>Symptom</u> If the SW3080 is not root and repeats between two other nodes and at least one of the connections is a <math>\beta</math>-mode connection, then asynchronous data transfers have a small chance of a Gap event being indicated before an Acknowledge (Ack) packet is transmitted. The result is the Ack packet being ignored and the data packet being retransmitted; slightly lower Asynchronous data throughput will result.</p> <p><u>Occurrences</u> This issue only occurs in <math>\beta</math>-only or Hybrid networks with three or more nodes. It does not occur in two-node networks and DS-mode (only) networks. It only occurs if the SW3080 is not root.</p>

<p>A. Setting the gap count to 10 (decimal) or higher greatly reduces the probability of this issue occurring. Many systems leave the gap count at 0x3F, which is excessively long and some systems set the gap count to 0x01, which is generally too short.</p> <p>B. Set the SW3080 to be the root of the network.</p>
